Minnesota State Patrol

District 4700 – Office of Pupil Transportation

Subject: Inspection Item Update

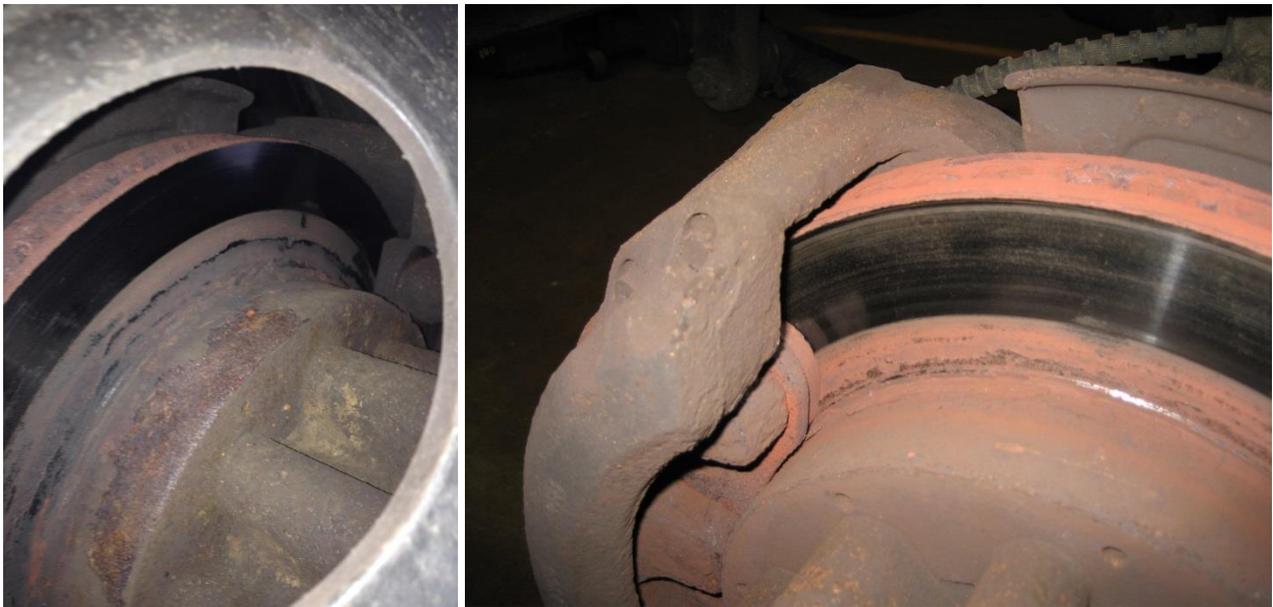
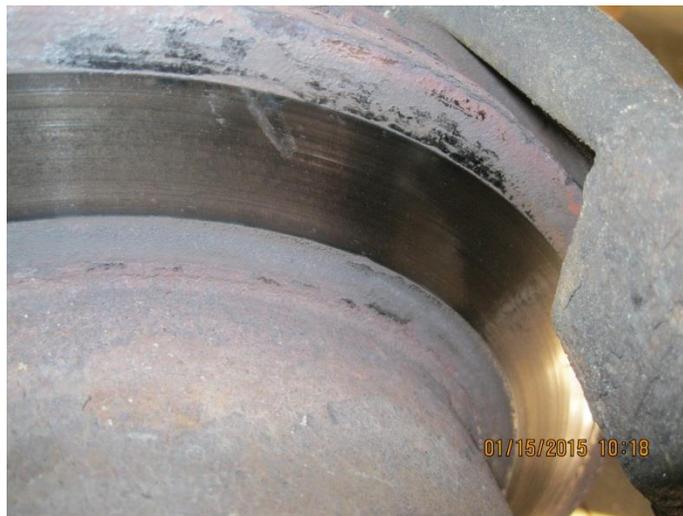
During annual and roadside inspections, performed by the Office of Pupil Transportation Safety, our staff has identified a concern with the abnormal corrosion of brake rotor surfaces and the deterioration of brake surface pads on hydraulic braking systems of school buses. These observations have raised concern regarding the loss of braking performance in an emergency brake situation. Based on these observations I contacted the school bus manufactures to seek input from their perspective.

In discussions with two of the brake engineers, it was confirmed the braking system is not performing as designed to ensure maximum braking potential as designed and immediate corrective action must be taken to address the situation. While the engineers could not pin point a single specific cause of our observations they suggested it may be related to but not limited to; brake rotors not being resurfaced (turned) when new pads were installed, improper fitting of the brake pads, caliper slide pins not functioning or maintained properly per the manufactures recommendations causing them to bind or a brake caliper piston issue.

As shown in the following pictures, the brake pad fails to maintain a solid or full contact with the brake rotor surface as required, resulting in the loss of maximum braking potential as designed.

Brake components discovered in this condition will be documented as “defective” and the school bus placed out-of-service per the Minnesota School Bus Inspections Standards. Please note, light “surface rust” resulting from a vehicle sitting for short periods of time *will not* be considered in violation.
